The Veil of Obscuration: Additional Radiographic Sign of Posterior Shoulder Dislocation

Objective. To describe a new radiographic sign, “veil of obscuration”, associated with posterior glenohumeral joint (shoulder) dislocations and determine its incidence and validity compared to other known classic radiographic signs. **Methods.** Four-year retrospective study identified 30 acute posterior shoulder dislocation patients. Radiographs reviewed in consensus by 2 musculoskeletal radiologists for the “veil of obscuration”, seen on AP shoulder radiographs and representing a comminuted fracture of the lesser tuberosity projecting over the humeral head or glenohumeral joint. Incidence of this radiographic sign of posterior glenohumeral joint dislocation in addition to other previously described classic radiographic signs, and association with other fractures, surgery, and mechanism of injury were evaluated. Continuous data was analyzed with student t-test and categorical data with Chi-Square test. **Results.** There were 20 right and 10 left posterior shoulder dislocations. Majority of injuries resulted from vehicle crash (44%). In most cases, reverse Hill-Sachs lesion (83%) and fixed int

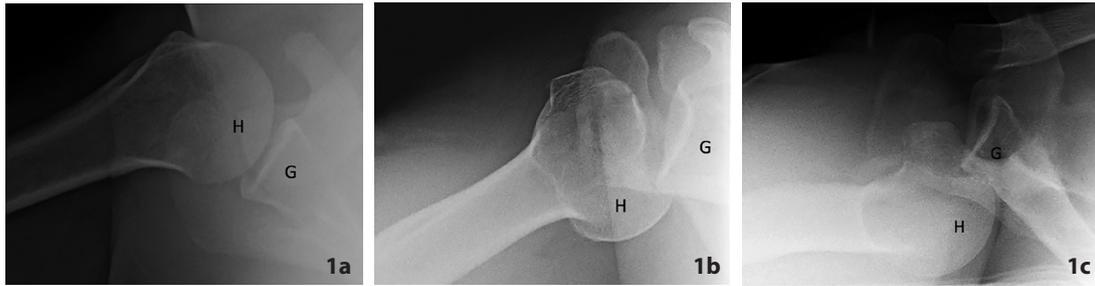
Figure 1. Axillary radiographs of the normal and posteriorly subluxed or dislocated glenohumeral joint. In (a) note normal anatomic alignment of the glenohumeral joint, with the humeral head well seated in the glenoid fossa compared to (b) which shows posterior subluxation of the glenohumeral joint, with the humeral head partially posteriorly displaced in relation to the glenoid, and (c) which demonstrates posterior dislocation of the glenohumeral joint, with the humeral head displaced completely posterior to the glenoid. H=humeral head, G=glenoid.

locations are common, accounting for 50% of all joint dislocations (2, 3), although posterior shoulder dislocations comprise less than 2-5% of all shoulder dislocations (2-4). A posterior shoulder dislocation is defined as posterior displacement of the humeral head in relation to the glenoid (Figure 1). These dislocations most frequently occur in male patients between 20 and 49 years of age

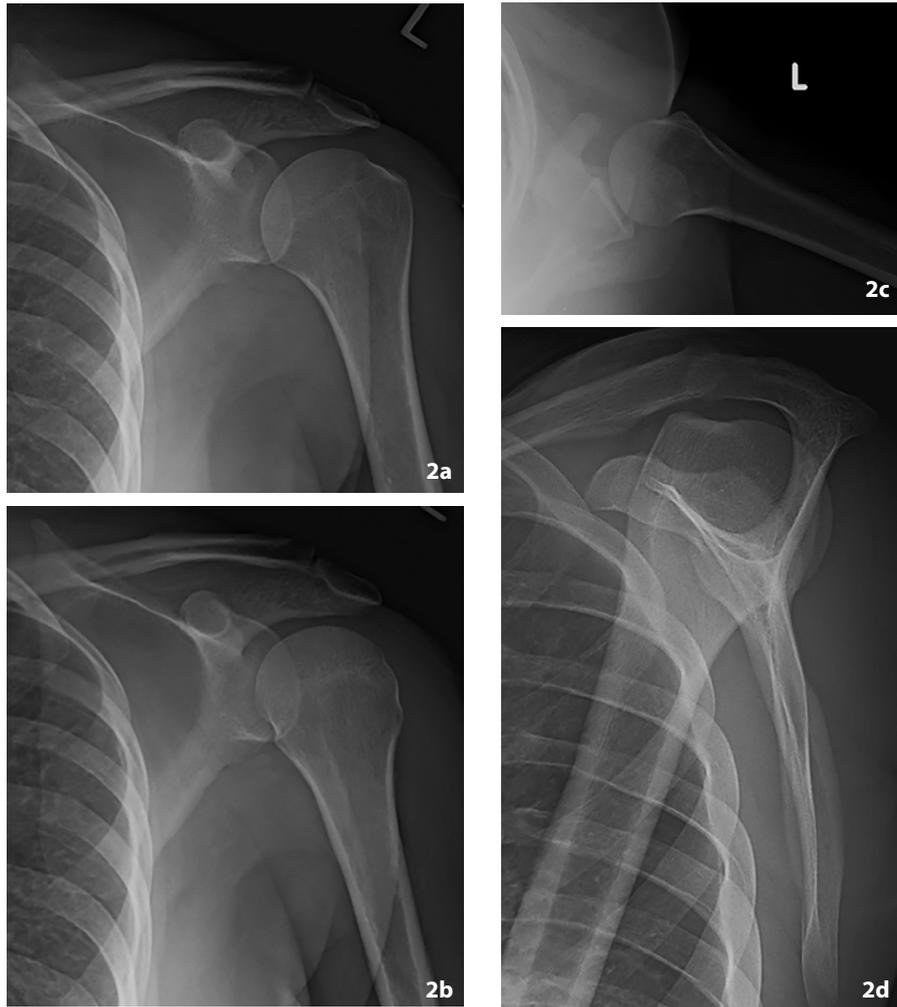
Figure 2. Routine shoulder radiographs. The complete radiographic examination of the shoulder consists of anteroposterior (AP) radiographs in (a) external rotation and (b) internal rotation and (c) an axillary view. When an axillary view cannot be obtained due to pain and difficulty with arm abduction, (d) a scapular “Y” view may be obtained.

diographs in internal and external rotation and either axillary or scapular “Y” views (5, 7) (Figure 2). While an axillary view can confirm the diagnosis, there can be limitations in obtaining this view in patients with posterior shoulder dislocations due to pain and difficulty with arm abduction (4). In these cases where it is difficult to obtain an axillary radiograph, a scapular “Y” view is recommended (8). Computed tomography (CT) may be performed to clarify or confirm the findings if clinically indicated. In addition to CT, magnetic resonance (MR) imaging and MR arthrography may help to further characterize associated bone and soft tissue injuries, but is not indicated in the acute clinical setting and may not be readily available in many academic institutions worldwide (9, 10).

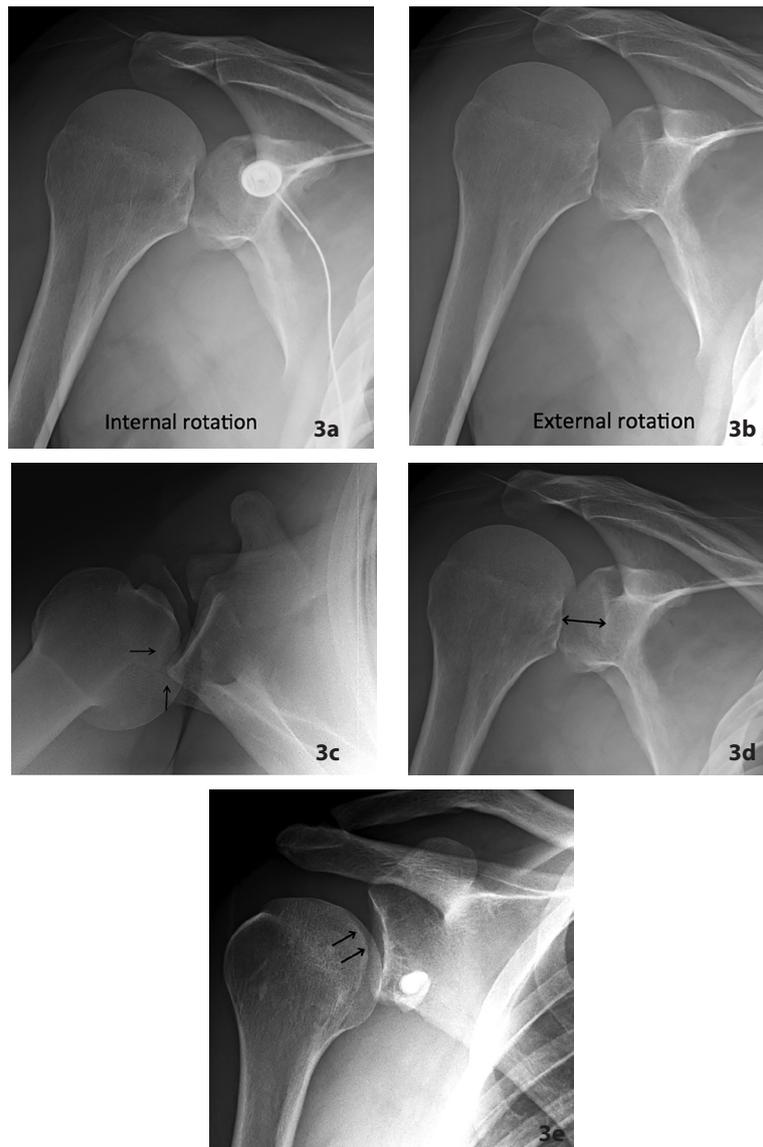
Figure 3. Classic radiographic findings of posterior shoulder dislocation. In (a) AP internal rotation and (b) attempted AP external rotation radiographs of the right shoulder, the humeral head remains in fixed internal rotation on both imaging projections. (c) Axillary radiograph of the right shoulder in a different patient shows an impaction fracture at the anteromedial aspect of the humeral head (arrows) consistent with a reverse Hill-Sachs lesion. In (d), internal rotation AP radiograph of another patient, note a widened glenohumeral joint space (arrow) measuring 1.8 cm with inadequate overlap between the humeral head and glenoid. (e) AP radiograph of the right shoulder in another different patient shows a vertical line of cortical bone projecting over the superomedial aspect of the humeral head (arrows) corresponding to the trough line sign created by the margin of the humeral head impaction fracture. Surgical hardware projects over the inferior glenoid from prior screw fixation.

Knowledge and awareness of the radiographic findings which facilitate the diagnosis of posterior shoulder dislocations are required. These include fixed internal rotation of the humeral head (Figure 3a-b), impaction fracture at the anteromedial aspect of the humeral head (reverse Hill-Sachs lesion) (Figure 3c), widening of the glenohumeral joint space with lack of humeral head and glenoid overlap in AP projection (Fig-

ure 3d), and the “trough line” (Figure 3e), a vertical line of cortical bone seen at the edge of a compression fracture at the anterior superioromedial aspect of the humeral head (3, 4, 11, 12).

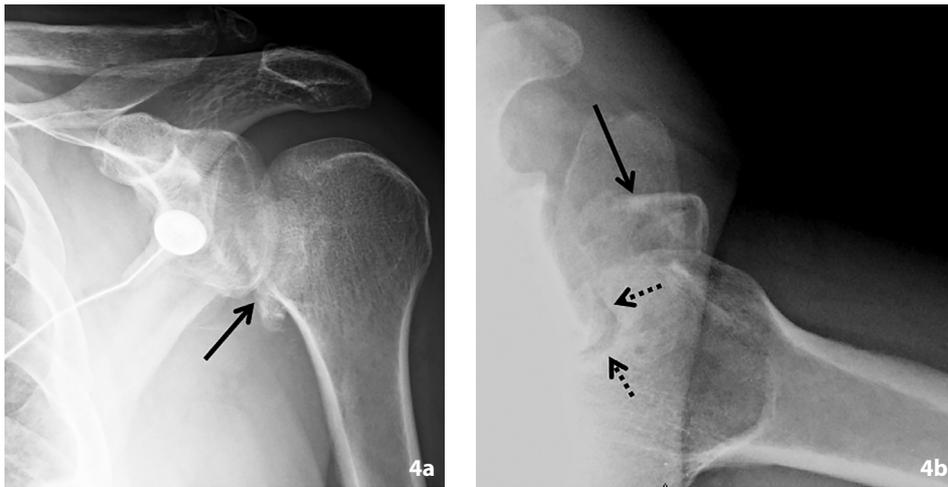
Figure 4. The “veil of obscuration” radiographic sign. (a) AP internal rotation radiograph of the left shoulder shows a displaced comminuted lesser tuberosity fracture (solid arrow) creating the “veil of obscuration” radiographic sign. (b) Axillary radiograph of the same shoulder demonstrates the displaced fracture of the lesser tuberosity (solid arrow). Also note posterior dislocation of the humeral head in relation to the glenoid with large reverse Hill-Sachs lesion at the anteromedial aspect of the humeral head (dashed arrows).

To further assist the emergency physician in identification of posterior shoulder dislocations, we describe an additional radiographic sign of posterior shoulder dislocation that we refer to as the “veil of obscuration” (Figures 4 and 5). This sign is seen on AP shoulder radiographs and represents a frequently comminuted fracture of the lesser tuberosity projecting over the humeral head or glenohumeral joint creating a

glenohumeral joint dislocations. The principle fracture fragment is flat and disc-like shaped. It is typically displaced inferiorly and medially with respect to the humeral head and seen en-face on AP radiographs (Figures 4 and 5). In this projection, the fragment is usually poorly defined and appears as a veil or cloud-like density which obscures underlying bony detail (Figure 4). The “veil of obscuration” was so named because the “veil” created by the overlying displaced bone fragments often obscures the

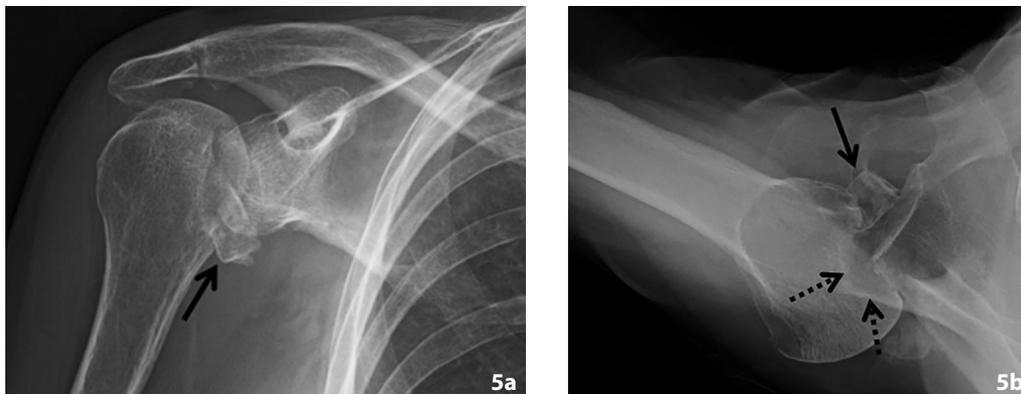
Figure 5. Sharply defined “veil of obscuration” radiographic sign. (a) AP internal rotation radiograph of the right shoulder shows a comminuted lesser tuberosity fracture (solid arrow) creating the sharply demarcated “veil of obscuration” radiographic sign. (b) Axillary radiograph of the same shoulder demonstrates a displaced fracture of the lesser tuberosity (solid arrow). Also note the humeral head is dislocated posteriorly in relation to the glenoid with large reverse Hill-Sachs lesion at the anteromedial aspect of the humeral head (dashed arrows).

underlying posterior dislocation. Rarely, the fragment is more sharply defined on the AP projections (Figure 5). The true nature of the bone fragment is best visualized on CT images with 2D and 3D reconstruction (Figure 6) which may not be available in routine emergency department practice.

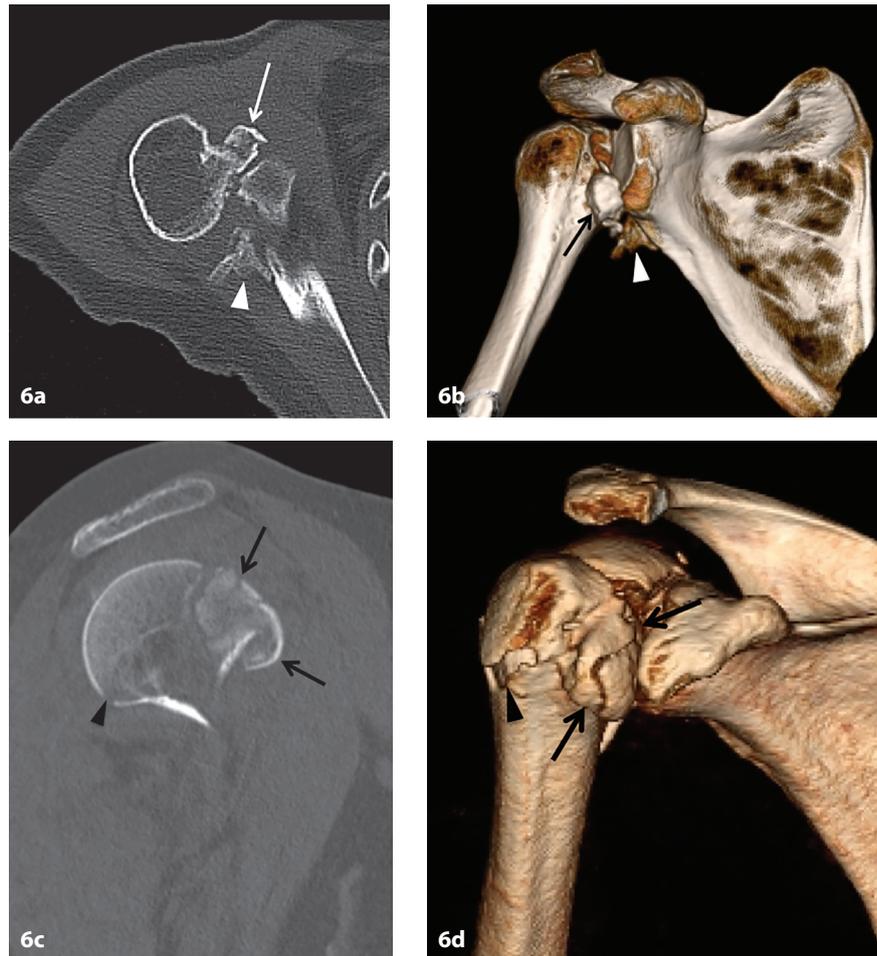
Figure 6. CT images of the “veil of obscuration” in the setting of posterior shoulder dislocations. (a) Axial and (b) 3D CT reconstruction images of the right shoulder clearly demonstrate a mildly displaced lesser tuberosity fracture fragment consistent with the “veil of obscuration” sign (arrow) and a displaced reverse bony Bankart lesion of the posterior glenoid (arrowhead). The humeral head is posteriorly subluxed. (c) Sagittal and (d) 3D CT reconstruction images of the right shoulder in another patient clearly demonstrate a mildly displaced comminuted lesser tuberosity fracture consistent with the “veil of obscuration” (arrows). Also note an associated comminuted humeral surgical neck fracture (arrowheads) as well as additional comminution of the humeral head. The humeral head is posteriorly subluxed, which was better seen on the axial CT images (not included).
